PCB-Caulk Replacement Project Johnson Space Center Houston, TX

16-May-2011

PCB Caulk Project at NASA JSC

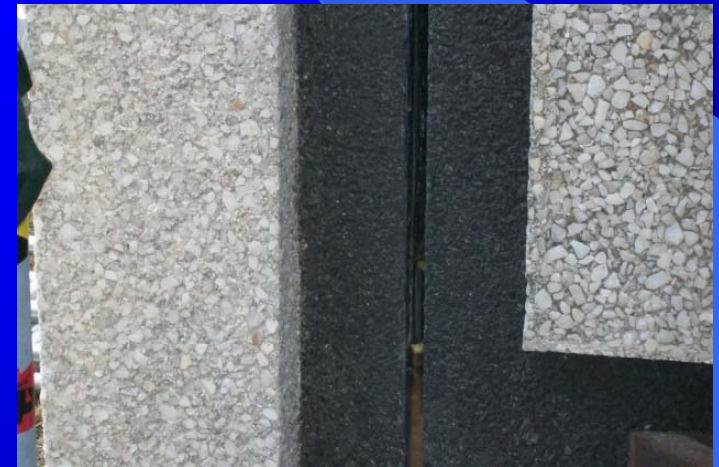
- NASA JSC in Houston, TX has over 130 buildings on an 1,620 acre campus.
 - Buildings in Mall area (built in 1960s) are primarily covered with PEAF Panels with caulk expansion joints between panels.
 - PEAF panels were high-pressure washed many times over the years.
 - Caulk between panels had been replaced in sections.
 - Gaps between PEAF Panels ranged from 1/8-inch to 1 inch wide.
 - Many buildings had developed leaks in caulking after Hurricane Ike hit the Center in September 2008.

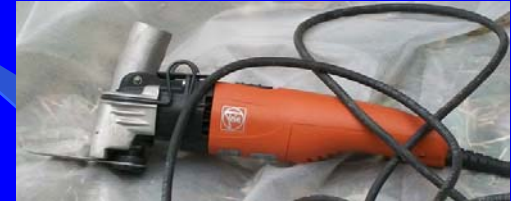
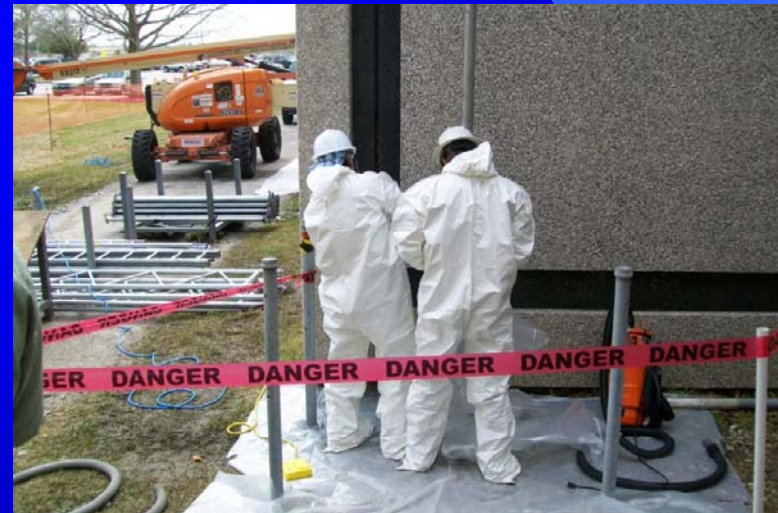
- Initially remove as much existing caulk as possible with reciprocating blade or utility knife wearing full-face respirator and coveralls
 - PCB (Skin contact)
- Grind PEAFF Panel to provide abraded cleaned surface for new caulk. Grinders equipped with HEPA vacs
 - PCB (Skin and Inhalation)
 - Other (PNOC/PNOS) dusts
 - Silica (Si) Dust
- Insert backing rod
- Apply primer
- Apply new caulk

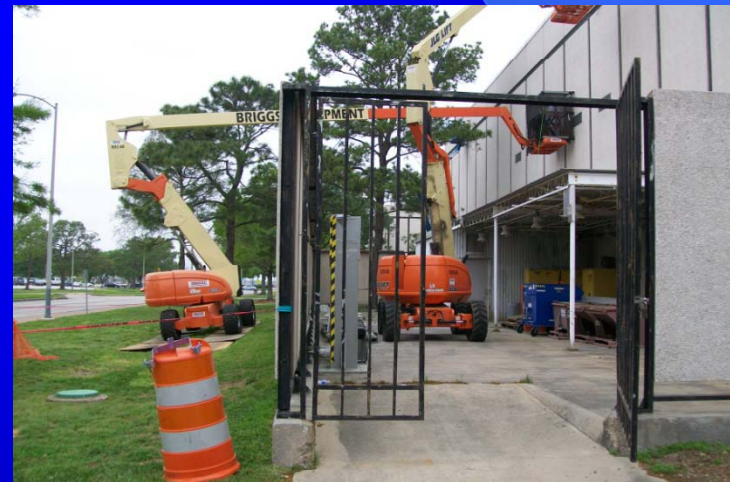
- Work plan to evaluate
 - Wet methods vs. dry methods,
 - Caulk removal blades (serrated vs. smooth),
 - Grinder blades, etc.
- Collect personal air monitoring for:
 - PNOC, PNOC-R, Silica-R, Grinder Dusts Bag Bulk–PCB, PCB vapors and dust
 - Evaluate PPE requirements

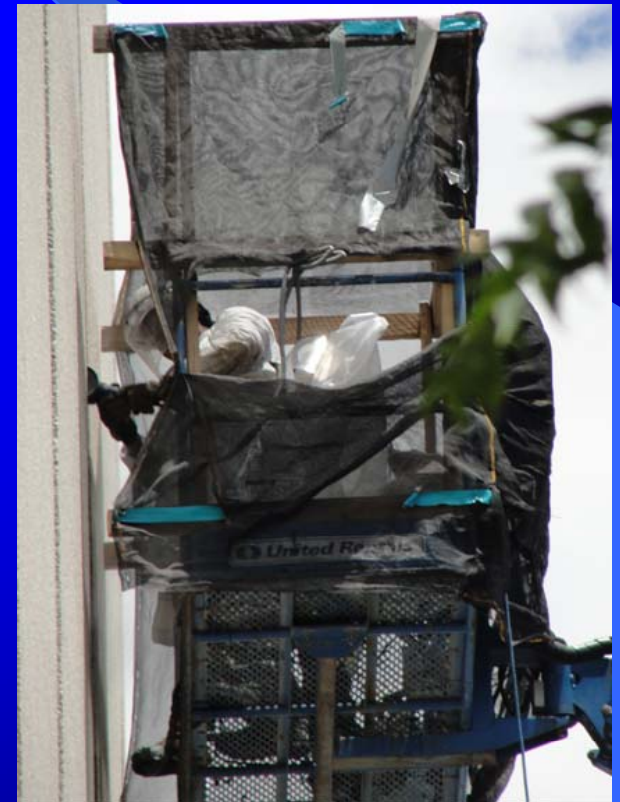
- Use experienced asbestos workers.
- Don PPE – Saranex-Coated Tyvek suit, initially FF Respirator w/P100 cartridges; after initial monitoring - Faceshield and side-shield safety glasses
- Use a mini-enclosure during grinding
- Wet the area
- Use reciprocating saw or utility knife to slice both sides of caulk
- Pull bulk caulk and put in containment
- Continuously wet the surface
- Use grinder to prepare surface
- Prime & apply caulk next day
- Air Monitoring
 - Personal PNOC & PNOC-R
 - Silica-R

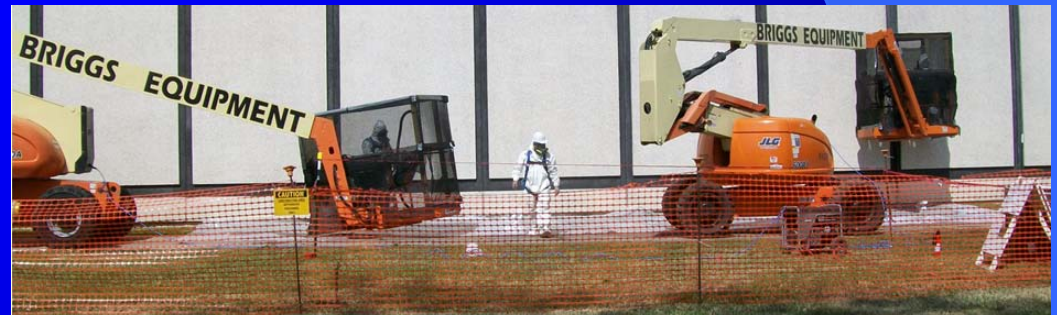
- Workers using wet methods were allowed to downgrade from full-face respirators to no respirators and face-shield PPE
- Saranex-Coated Tyvek coveralls were replaced with sleeved smocks to reduce heat stress
- Serrated blades were evaluated to eliminate grinding the surface with a disc grinder. The blades did not abrade the surface enough so smooth blades were used on the reciprocating saw to reduce dust.

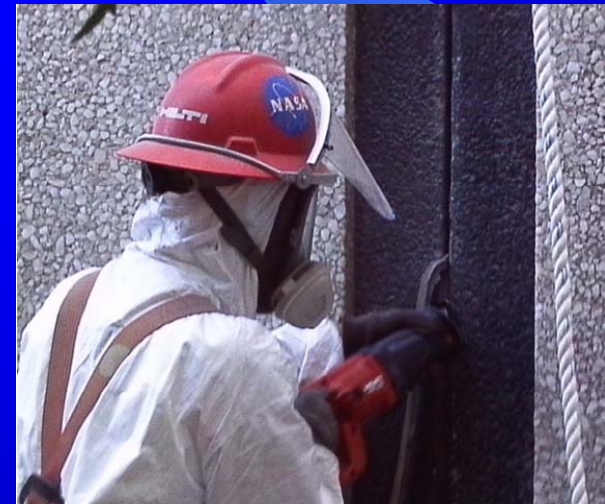
- Use professional building waterproofers
- Don PPE – Tyvek suit, FF Respirator w/P100/OV cartridges
- Use reciprocating saw or utility knife to slice both sides of caulk
- Pull bulk caulk and put in containment
- Use grinder to prepare surface
 - Shroud & vacuum to minimize dust emission
- Apply primer & caulk on same day
- IH Air Monitoring Plan
 - Personal monitoring for PCB vapors and dusts
 - Personal & area monitoring for Silica-R
 - Personal & area monitoring for PNOC & PNOC-R (some in manlift)
